# Use of damage in fire investigation: a review of fire patterns analysis, research and future direction

Gregory E Gorbett<sup>1,2\*</sup>, Brian J Meacham<sup>1</sup>, Christopher B Wood<sup>1,3</sup> and Nicholas A Dembsey<sup>1</sup>

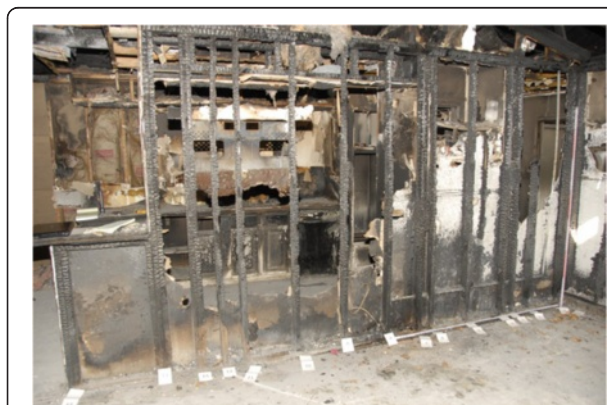
**Fig. 1** Wood stud wall with varying DOFD char damage

on a range from ‘Number 0 Char’ up to ‘Number 10 Char’, with number 10 char as representing the greatest level of damage. The level of damage was varied based on the visible appearance of the number of cracks within set distances and the widths of those cracks. For example, an investigator would assign a number 5 char level to a piece of wood that had “the number of cracks occurring up to 2 per centimeter with widths approximately the thickness of a five-cent piece” (Keith and Smith 1984). The DOFD as outlined in this article never received any traction within the community and has never been picked up in any other literature (Figs. 1 and 2).

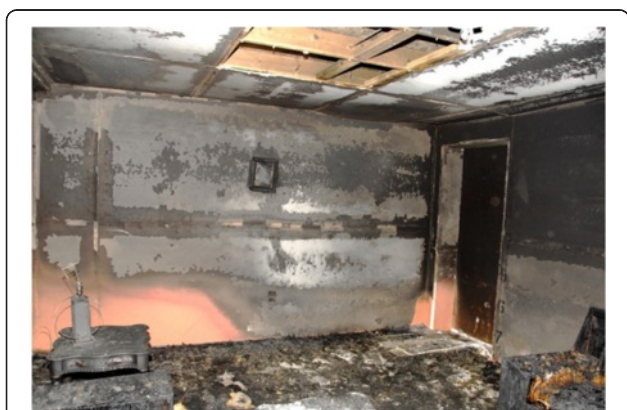
**Fig. 4** Varying degree of fire damage to gypsum wallboard-visible damage results

Hicks et al. (2006; 2008) conducted a fire pattern reproducibility study using single fuel items. Forty-eight tests were conducted with a standardized ANSI/UL wood crib and ten additional tests were conducted with commercially available polyurethane foam recliners. The fuels were burned against a gypsum wallboard lining material within a compartment lined with gypsum wallboard. Twelve thermocouples were mounted in a grid array above the fuel item to capture temperatures for the duration of the tests. These two studies demonstrated a relatively predictable response of visible damage to the gypsum wallboard consistent with the varying DOFD identified in NFPA 921 (Figs. 4 and 5).

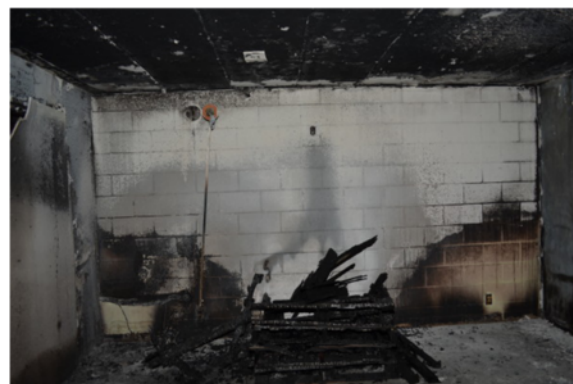
**Fig. 6** Photograph of a Conical-Shaped Fire Pattern along a concrete block wall (fire origin was located under the stack of wooden pallets-fire test conducted at EKU by author)

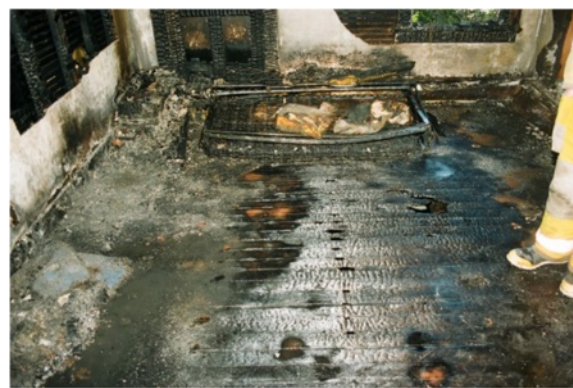
**Fig. 7** Scene photograph of suspected ignitable liquid pour (Wood et al. 2012)

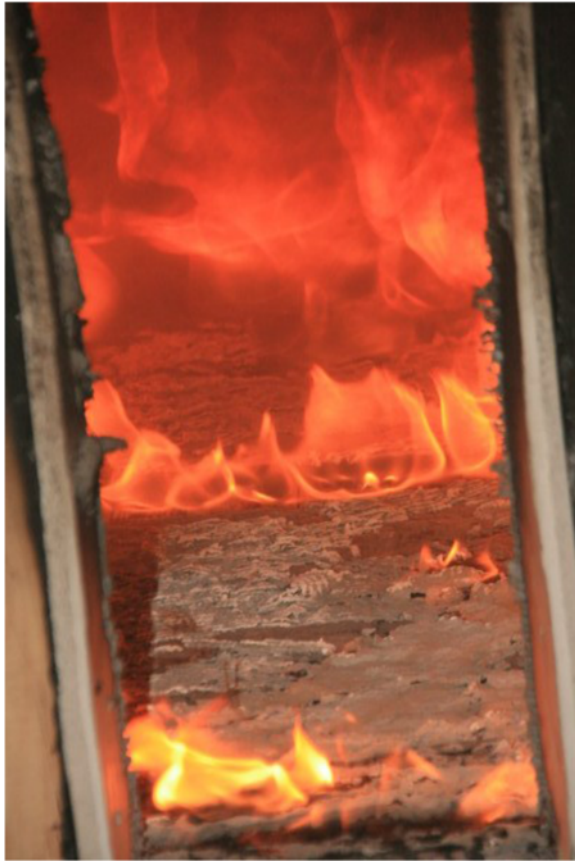
**Fig. 8** Testing photograph for carpet pad seam generation of pattern similar to reported ignitable liquid pour showing burning in exposed surface resulting from carpet pad shrinkage (Wood *et al.* 2012)

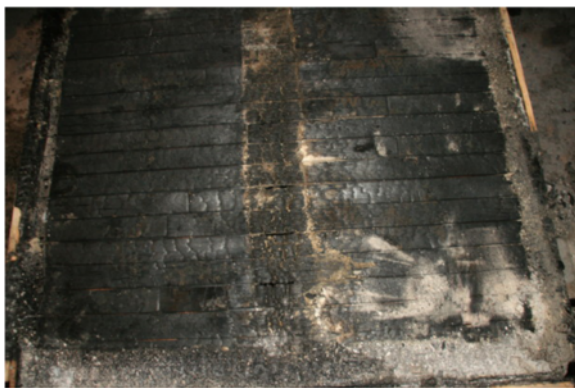
**Fig. 9** Resultant floor burn pattern from carpet pad seam without use of ignitable liquids (Wood *et al.* 2012)

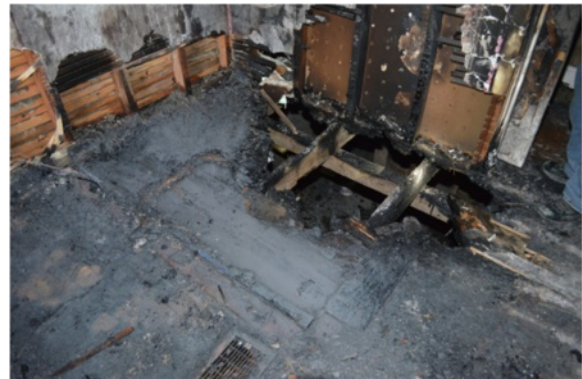
**Fig. 10** Photograph of penetration through a floor

against, so has floor penetrations by both the fire science and investigation communities (Babrauskas 2005; NFPA 2014). Alternative explanations are now commonly given when discussing penetrations through floors, including: radiant heat, furniture items, melting plastics and pre-existing openings in the floor during fully involved compartment fire (NFPA 2014) (Fig. 10).

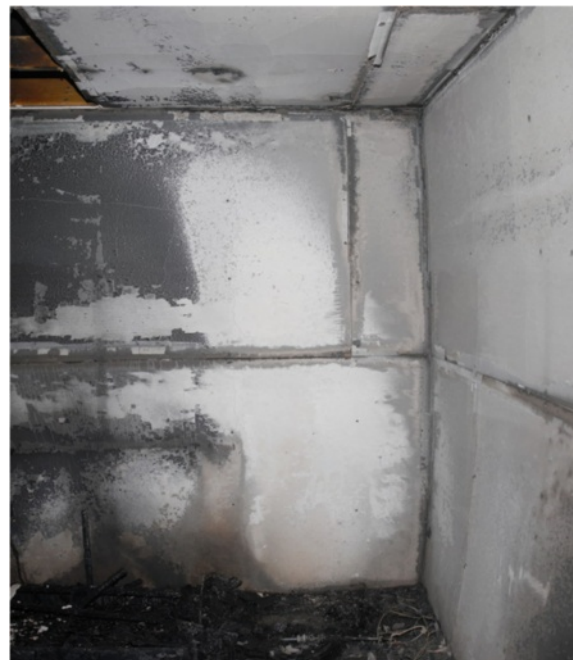
**Fig. 11** Photograph of a Plume-Generated Fire Pattern (fire origin was located at the base of this damage-test conducted at EKU by author)

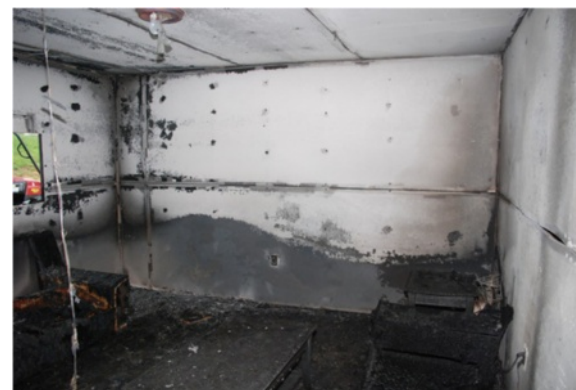
**Fig. 12** Upper Layer-Generated Fire Pattern (fire origin was located along adjacent wall-fire test conducted at EKU by author)

When the gases rise and expand, they begin interacting with the lining surfaces and contents in the flow of the fluid. Particulates and aerosols are deposited and heat is transferred in the same direction and flow as the smoke. As the gases rise and expand, they also begin to interact with ventilation openings. The movement of smoke from a compartment into an adjoining space is controlled by the density differences at the interface of the ventilation opening. Upper layer gases inside the compartment are driven by density differences due to their higher temperature and lower density. These gases are buoyant compared to the surrounding air at the opening interface, which causes them to flow through the opening, unless there is wind or some other external force (mechanical ventilation) allowing the pressure outside of the compartment to be higher. Therefore, the dynamic forces that drive flow through an opening are based on fluid dynamics and fluids in motion at the ventilation opening interface and the discharge characteristics of the opening. As the smoke exits the opening, it expands in volume and rises. Particulates and aerosols are commonly deposited on the wall and ceiling surface where the upper layer interacted with the lining surface (NFPA 2014). In addition, if these gases were undergoing flaming combustion as they exited the opening, thermal damage to the wall surface is expected to follow the same theory (DeHaan and Icove 2011). The resulting damage appears to be angled lines of demarcation with the lower end of the line of demarcation being nearest the source of the smoke flow (Fig. 12).

Characteristics distilled from the literature related that the ULG patterns will have level lines of demarcation with relatively uniform magnitude of damage, unless the upper layer is flowing from one location to another and,

if so, the lines of demarcation will be angled towards the opening.

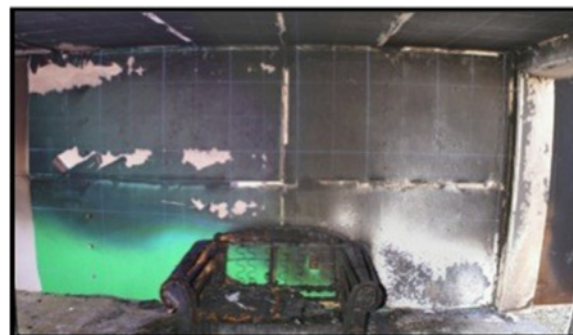
**Fig. 13** Ventilation-Generated Fire Pattern near open doorway (fire origin located across room-fire test conducted at EKU by author)

Characteristics of the damage linked with ventilation-generated patterns during ventilation-controlled conditions are large surface areas and increased magnitude of damage, angled lines of demarcation located around the ventilation opening or directly opposite of a door opening. Also, damage may be found near the unsealed seams of drywall sections due to infiltrating air.

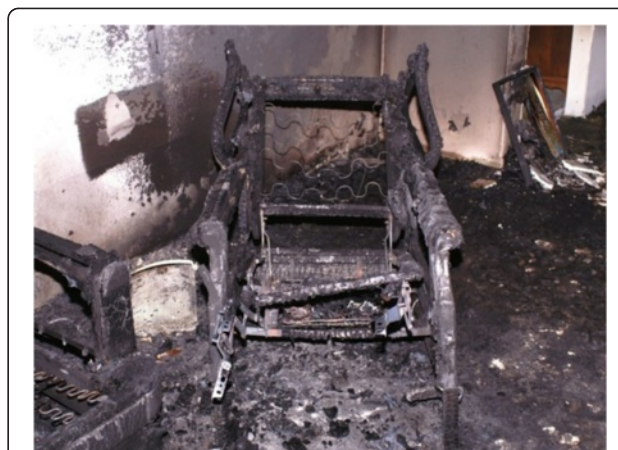
**Fig. 14** Pre-fire Drywall Repairs Influencing the Post-fire Visible Damage to the Wall (fire origin located along front of chair-fire test conducted at EKU by author)
